INSPECTION REPORT

For the Property at:
1111 YOUR NEW HOME DR.
YOUR CITY, TN 55555

Prepared for: JOHN SAMPLE
Inspection Date: Saturday, May 21, 2016
Prepared by: James Martin

Report No. 1082

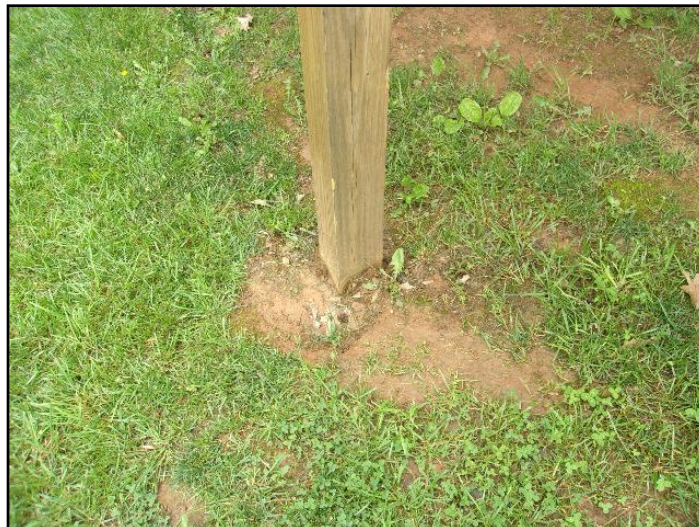
1. Condition: • Wood/soil contact

Implication(s): Weakened structure | Chance of movement | Rot | Insect damage

1. Wood/soil contact

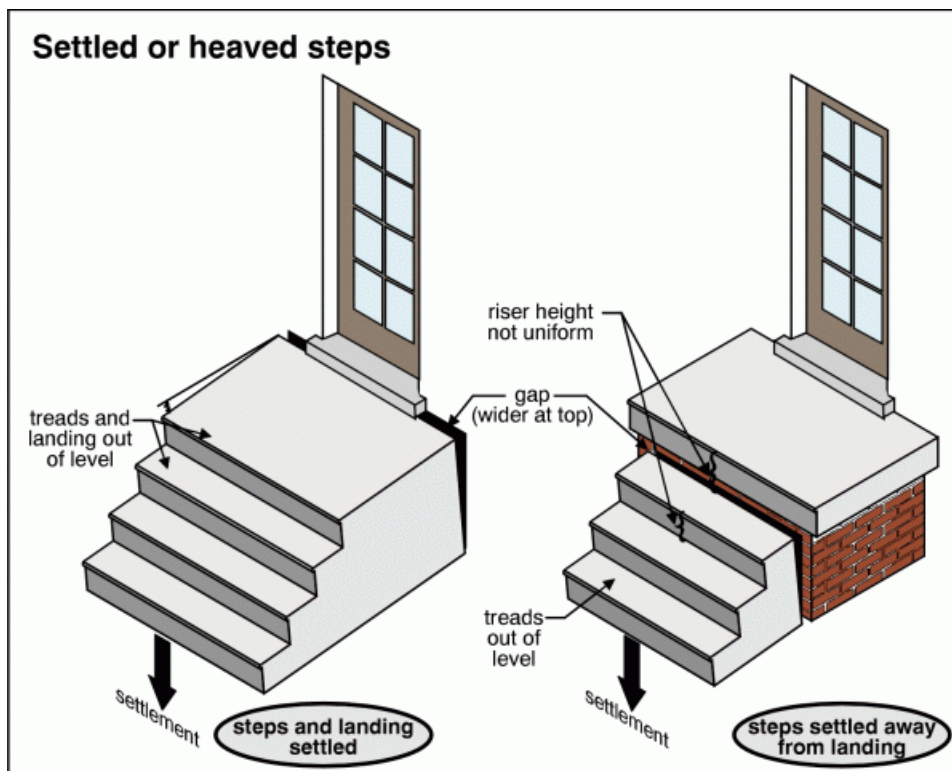
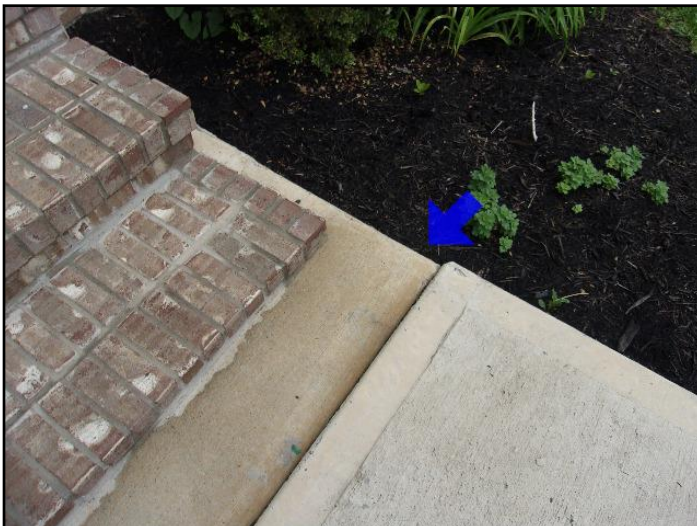
2. Condition: • Steps or landings settling or heaving

Causing top step height is a trip/fall hazard

Implication(s): Weakened structure | Trip or fall hazard

2. Steps or landings settling or heaving

Recommendation: Consult a Foundation Service contractor

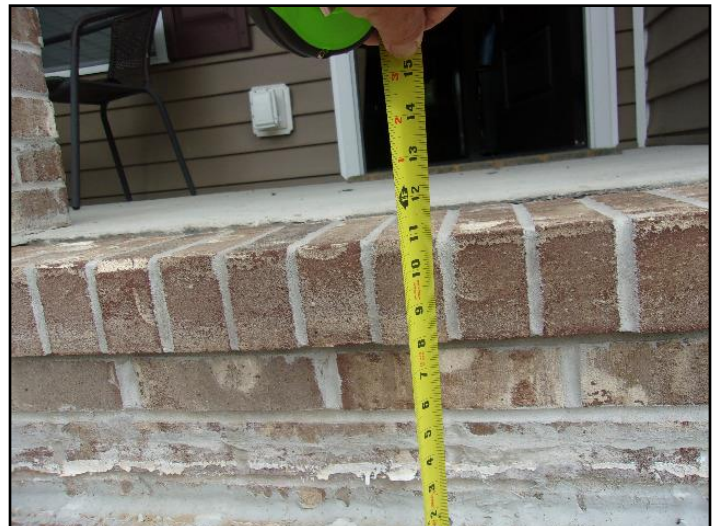
3. Top step height

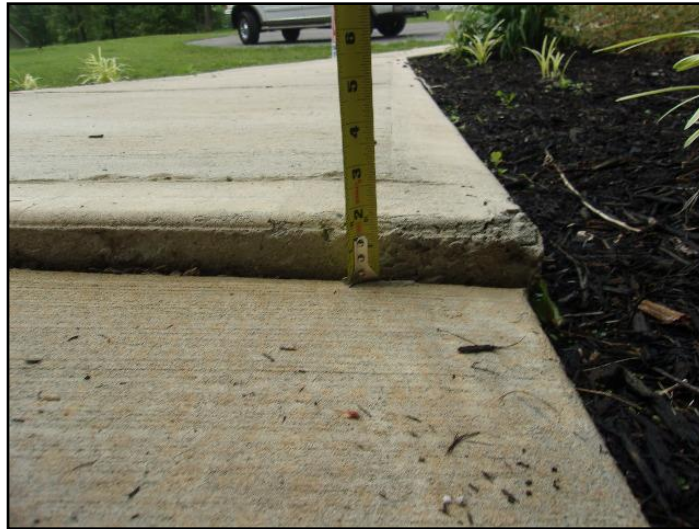
4. Steps or landings settling or heaving

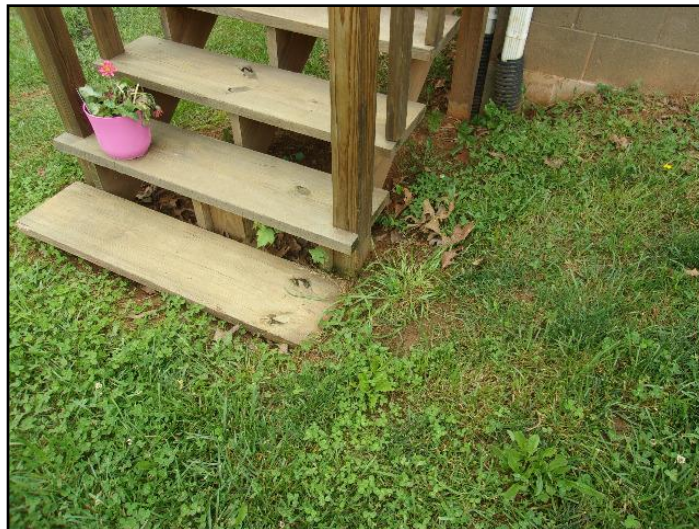
3. Condition: • Wood/soil contact

Implication(s): Shortened life expectancy of material | Material deterioration

5. Wood/soil contact

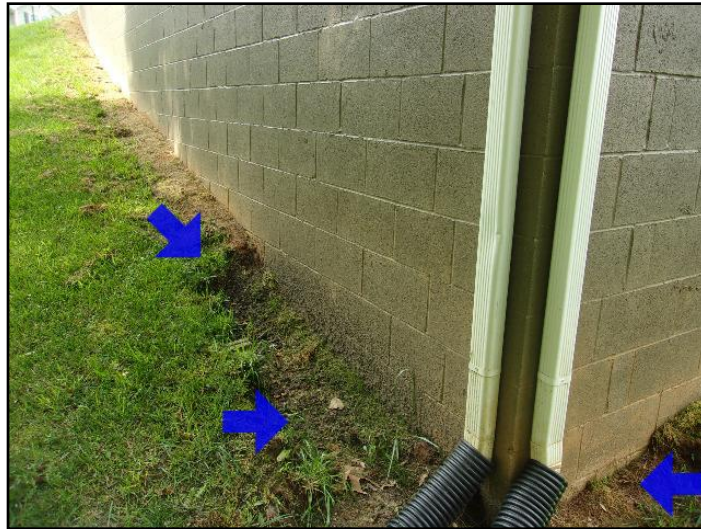
4. Condition: • Soil erosion

Implication(s): Chance of water damage to contents, finishes and/or structure

6. Hillside erosion

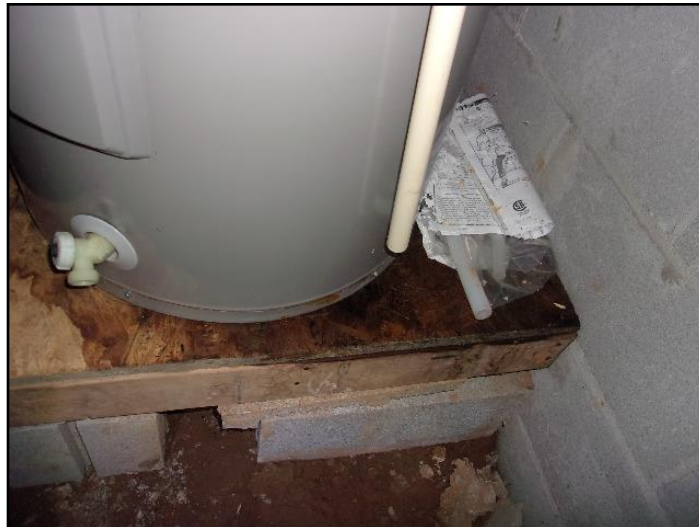
5. Condition: • Leak

Implication(s): Chance of water damage to contents, finishes and/or structure

9. Leak

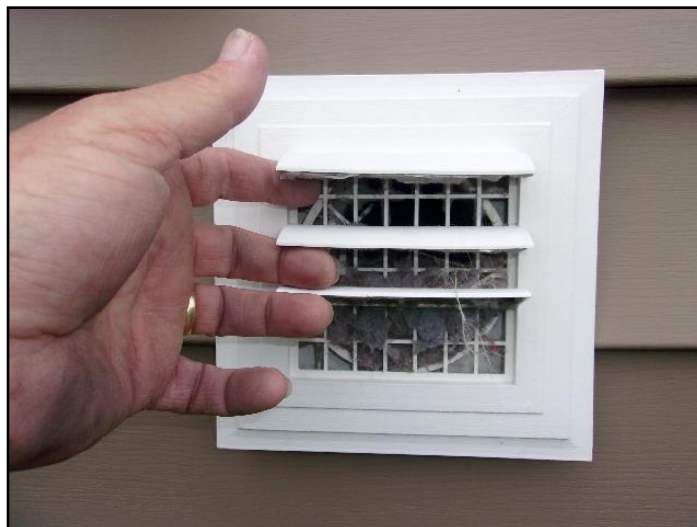
6. Condition: • Dryer vent obstructed

Implication(s): Equipment ineffective | Fire hazard

10. Dryer vent obstructed
